**SUBJECT: CLEAN WATER ACT, SECTION 308 INFORMATION REQUEST- OIL /
RELEASE IN TERREBONNE PARISH, LA 10/31/13**

Re: Written Notification
Hilcorp Energy Company
Cocodrie Dock Fuel Incident
Incident Date: October 29, 2013

Cocodrie Incident

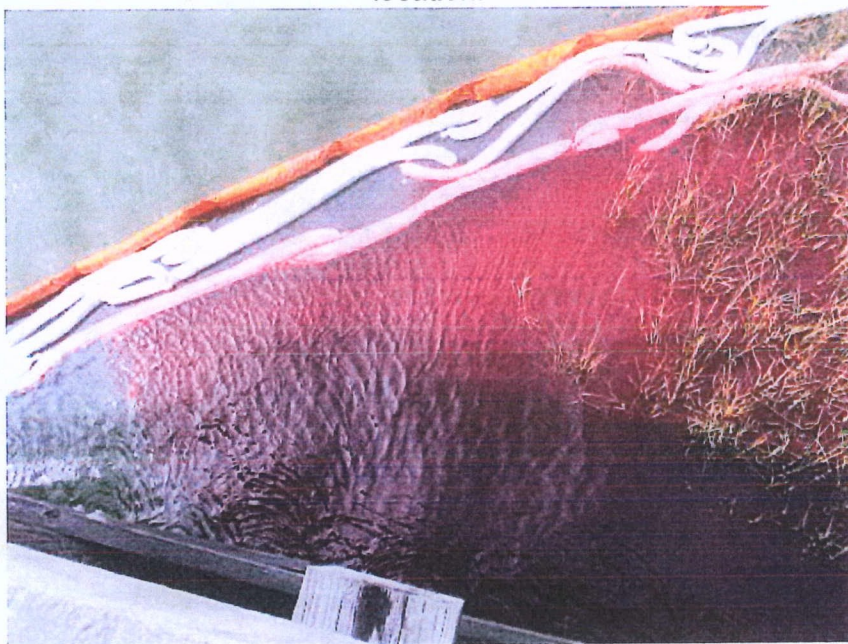
View of released product within containment boom in the western portion of the incident location.

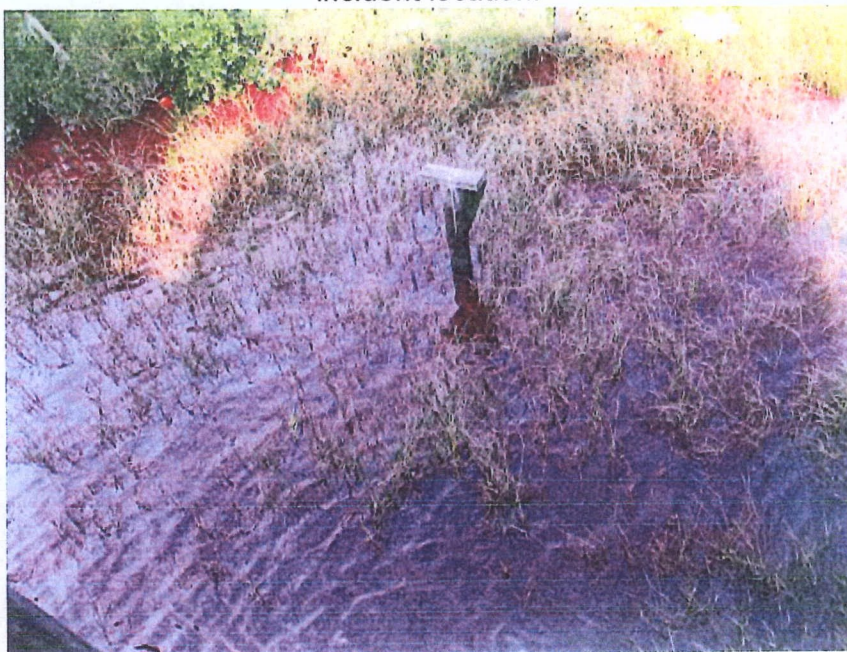
View of released product along the impacted shoreline in the western portion of the incident location.

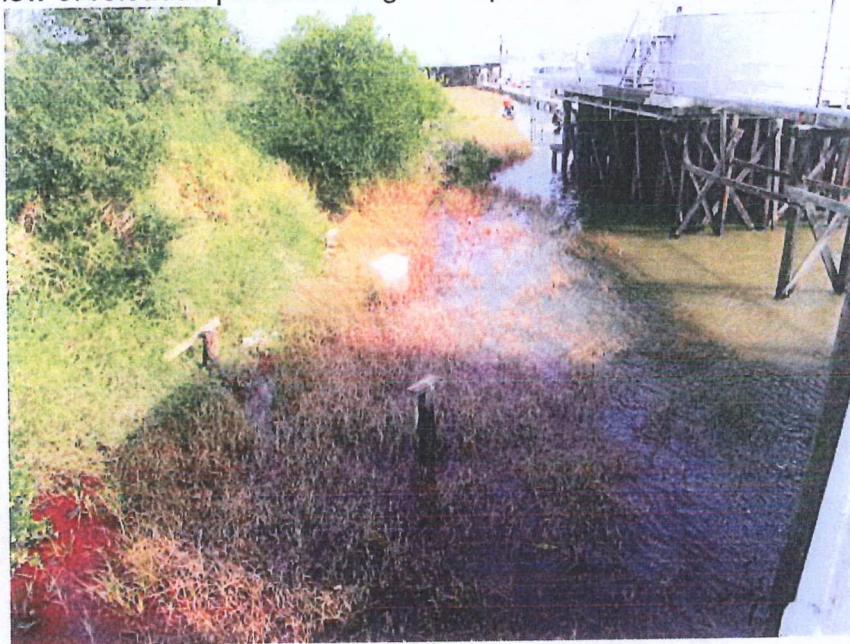
View of released product along the impacted shoreline facing east.

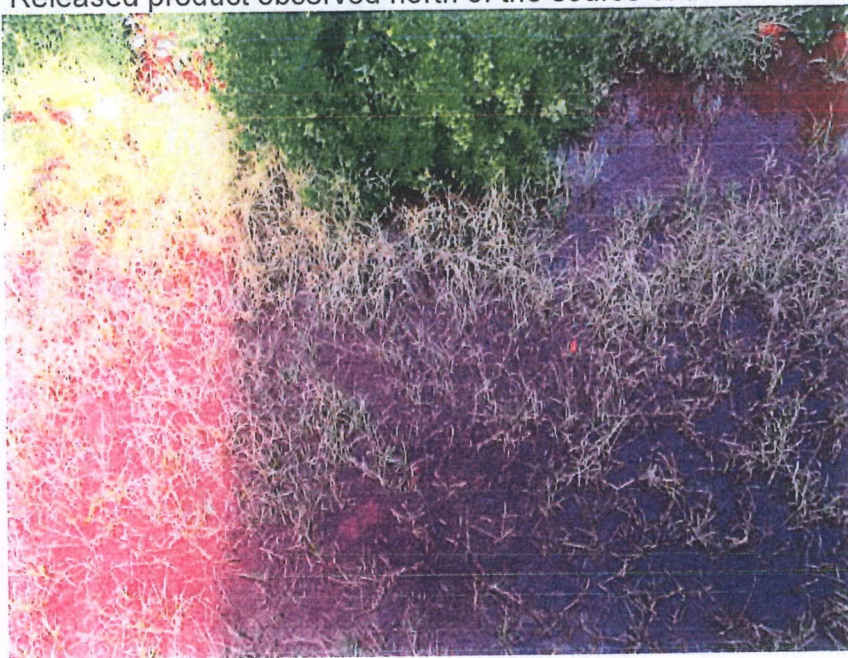
Released product observed north of the source of the release.

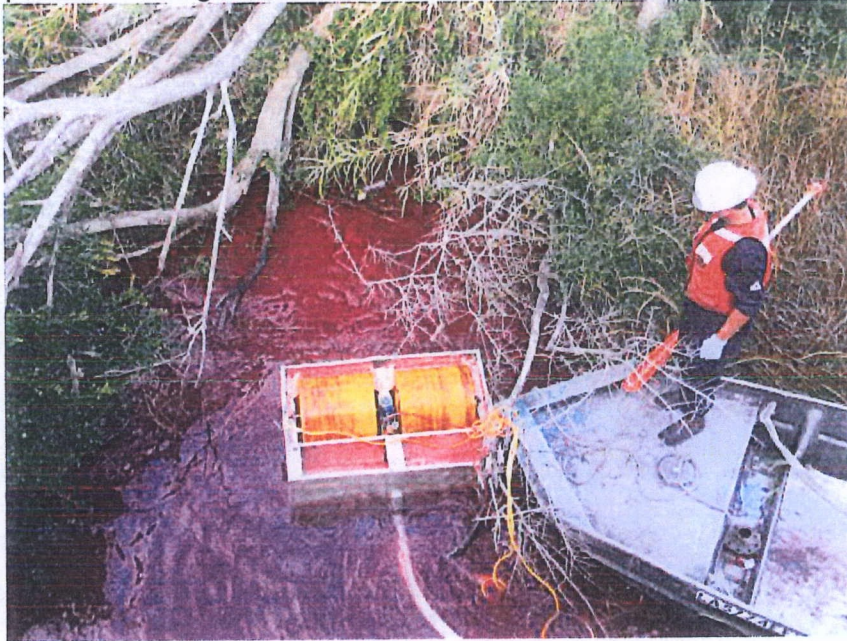
Skimming operations along the shoreline of the eastern portion of the incident location.

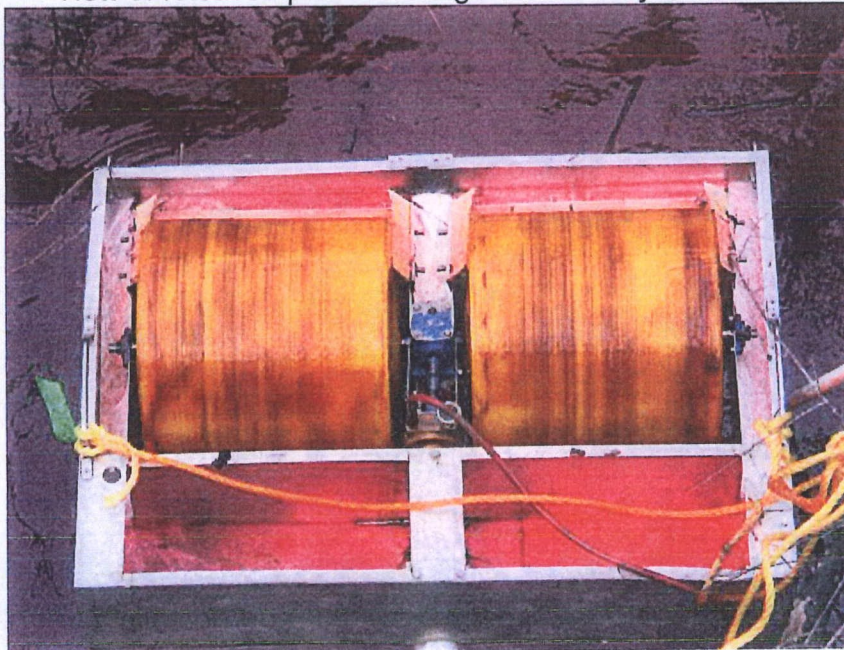
View of released product being recovered by a skimmer.

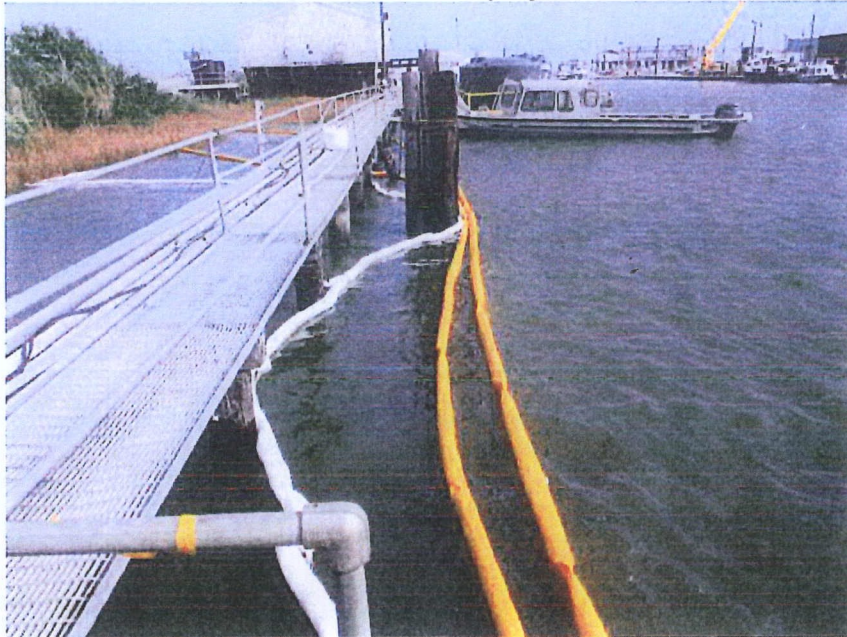
View of containment and absorbent boom deployed around the released product.

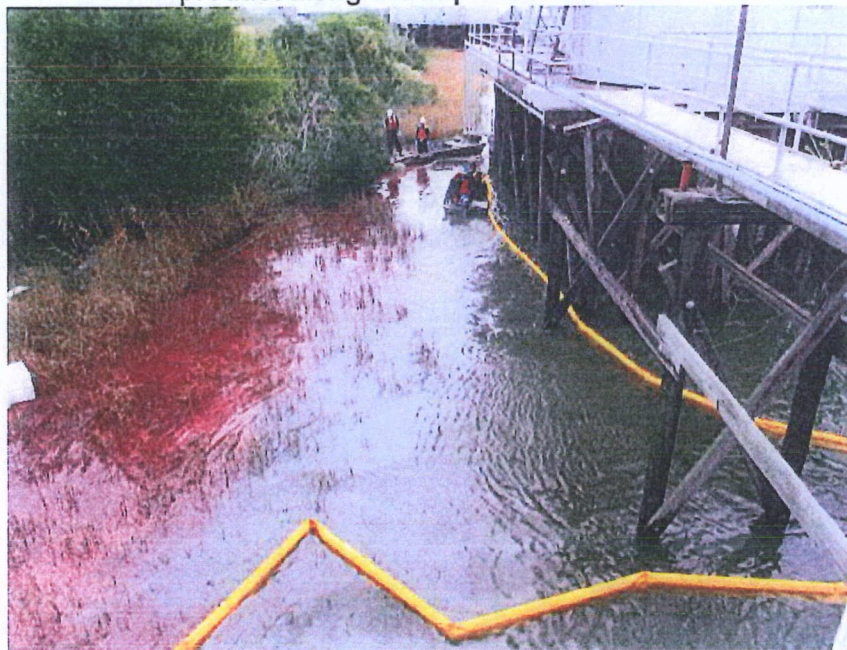
Response personnel deploying additional containment boom to contain the released product along the impacted shoreline.

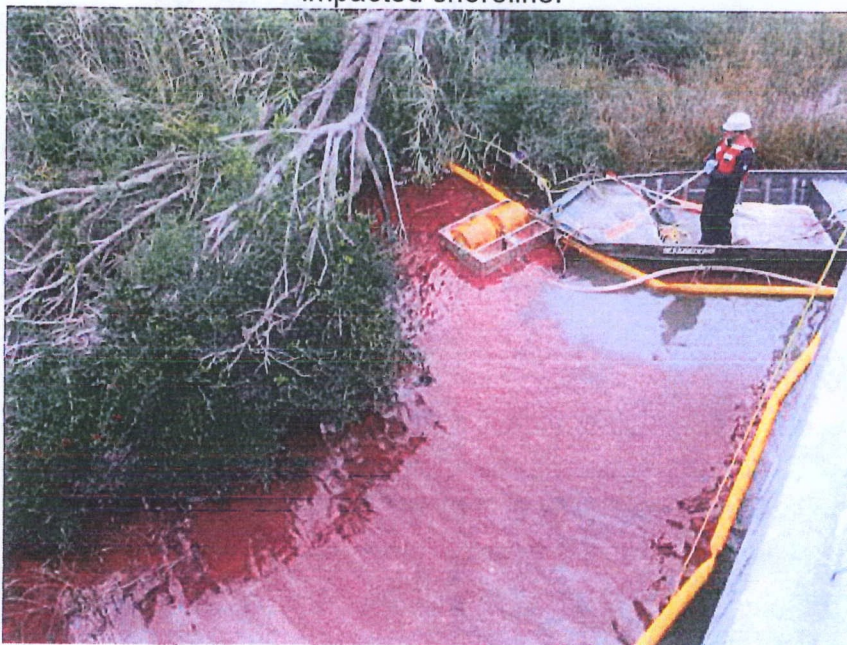
Skimming operations being conducted within containment boom deployed along the impacted shoreline.

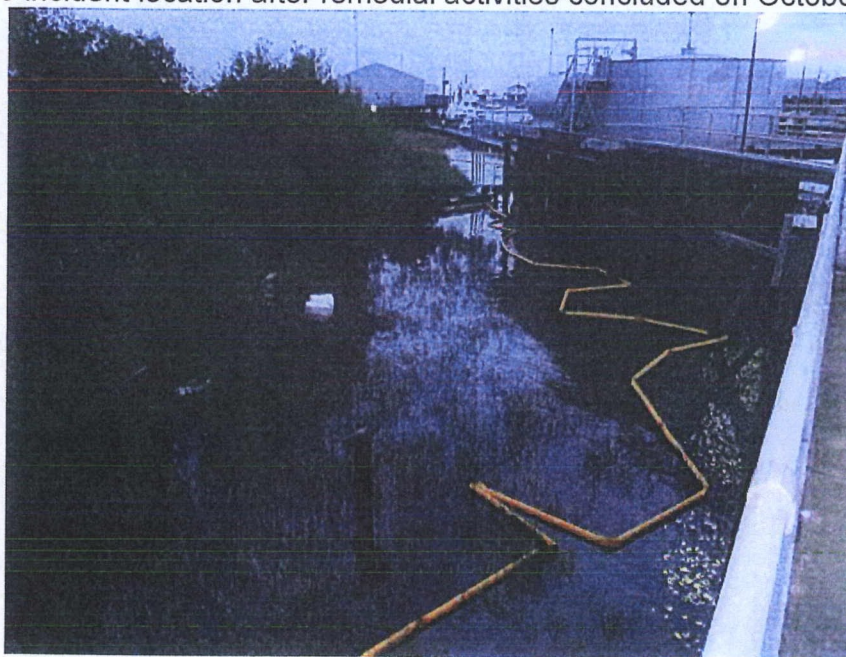
View of the incident location after remedial activities concluded on October 31, 2013.
